MONITORING OF THE LITTLE SNAKE RIVER AND TRIBUTARIES

YEAR 5 - FINAL REPORT

December 2005

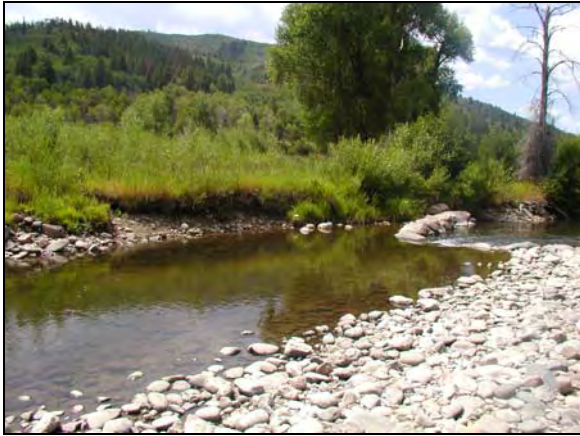
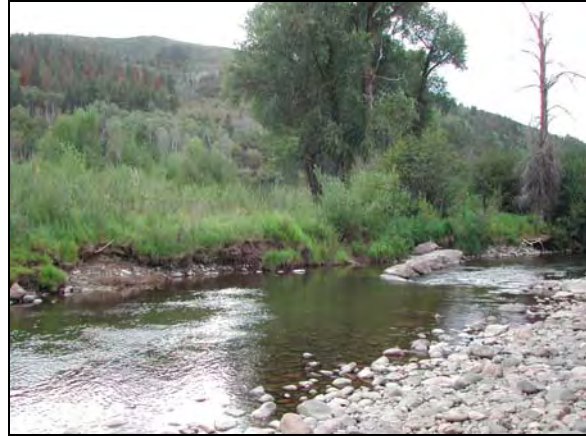
One location was noted in 2004 on the Main Stem upstream of the structure at XS4569 (40° 59.832' N, 107° 03.463' W). The left bank is eroding above the structure, as shown in Figures 28 and 29. This area was revisited in 2005. The bank appears to be slumping due to cantilevering, but dense vegetation on the failure will likely continue to protect it. No action is necessary at this time.

Figures 28-29: 2004 and 2005 photographs taken of bank erosion on the left bank upstream of the structure at XS4569 (40° 59.832' N, 107° 03.463' W).

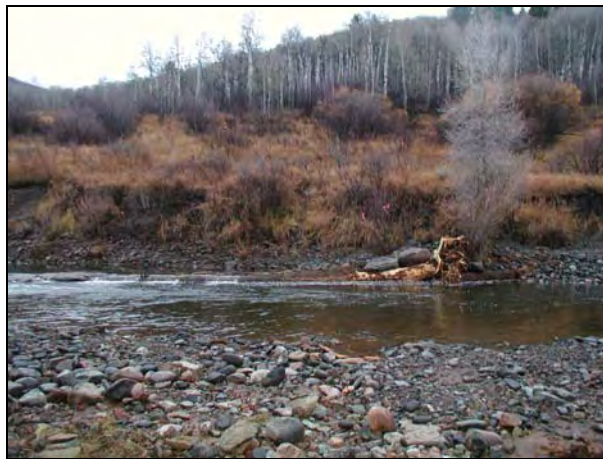
Figure 30: Photograph taken on October 20, 2005 of the new structure at the downstream end of the project site.

In the Fall of 2005, Wildland Hydrology added a structure at the downstream end of the project (Figure 30). The new structure is a J-hook extending from the left bank composed of log along the leg of the structure reinforced by boulders along the bank and at the tip of the structure.

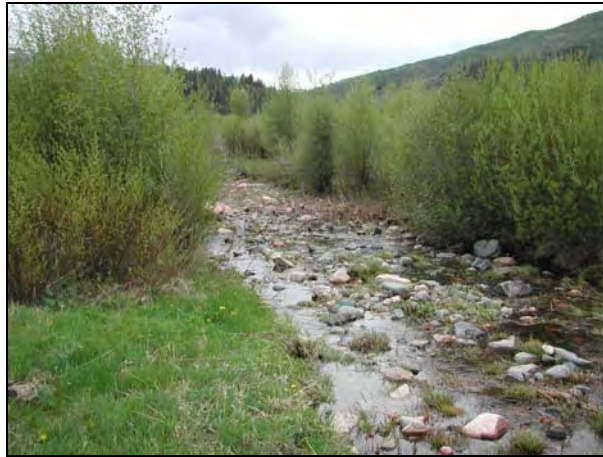
construction. However, the flow did get high enough in 2005 to enter this side channel (Figure 31), but this did not result in any stability problems at the island.

Figure 31: Flow in the channel behind the North Fork flow-meter island in 2005.

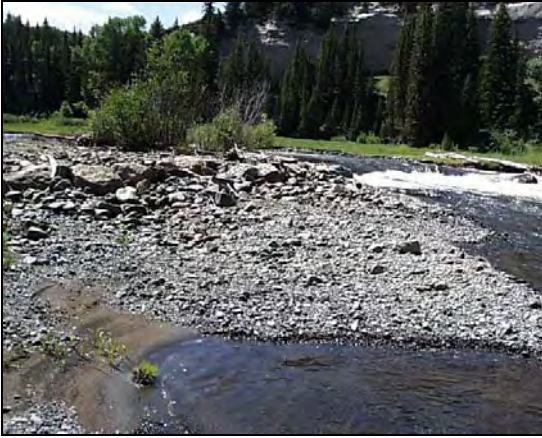
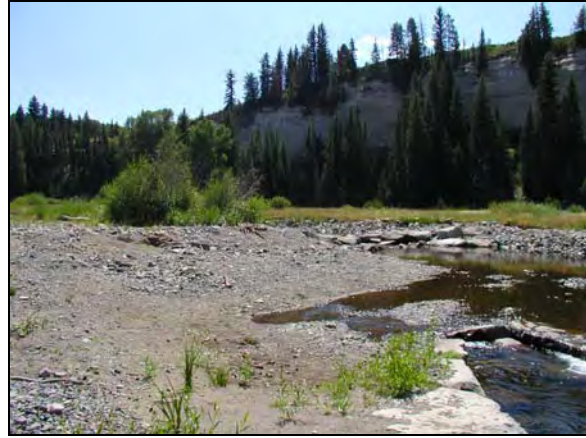
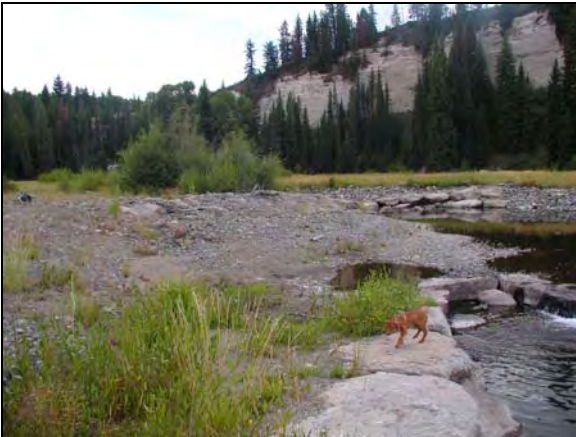
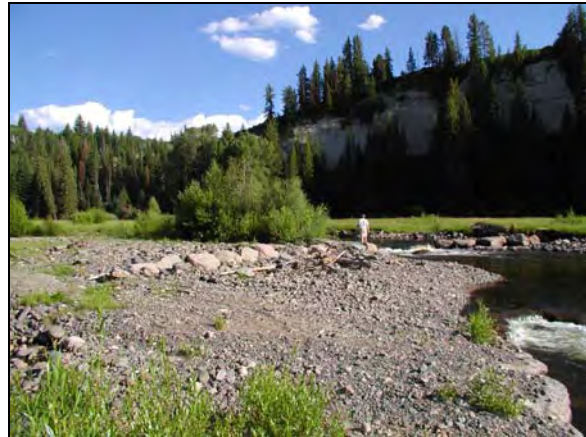
Two locations on the Middle Fork had been targeted for maintenance activities in the past. The first is in the vicinity of the W-weir on the Middle Fork ($40^{\circ} 59.211' N$, $107^{\circ} 2.283' W$) (Figures 32a-d). During high flows in 2003, tie-in rocks of the structure above the W-weir were exposed due to overbank flows and erosion of material covering the right tie-in boulders (Figure 32a). This resulted in downstream deposition of cobbles and gravels in the right side of the W-weir. After recession of the high flows, Three Forks Ranch personnel removed the deposited materials surrounding the W-weir and re-covered the tie-in boulders of the upstream structure (Figure 32b). This location was revisited in 2004 and 2005. Figure 32c shows that the deposition in 2004 is similar to that shown in Figure 32b. Figure 32d shows some uncovering of the tie-in boulders from the high flows in 2005. However, the structure remains stable and no action is required at this time.

Figures 32a-d: (a) Photograph taken on June 11, 2003, after high flows, showing the exposed tie-in boulders of the structure above the W-weir on the Middle Fork. Note the newly deposited material below the structure. (b) Photograph taken on August 15, 2003, after material removal and re-covering the tie-in rock. (c) Photograph taken on August 16, 2004, showing similar deposition as in (b) ($40^{\circ} 59.211' N, 107^{\circ} 2.283' W$). (d) Photograph taken on July 11, 2005, showing some uncovering of tie-in boulders during 2005 runoff. All photographs are looking upstream.

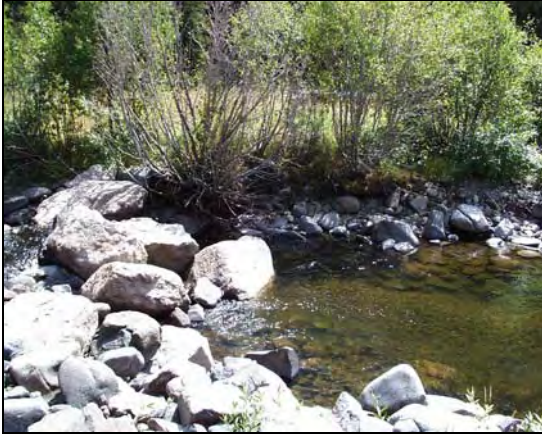
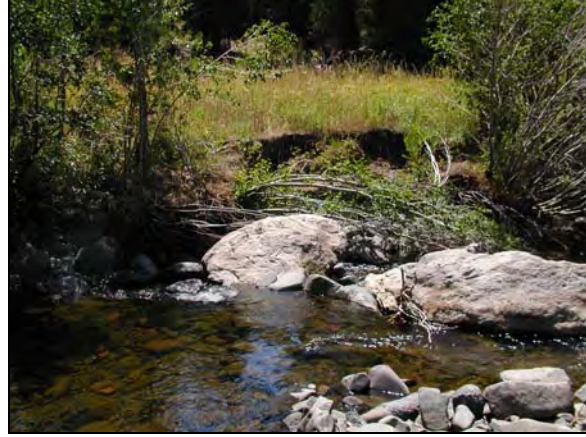
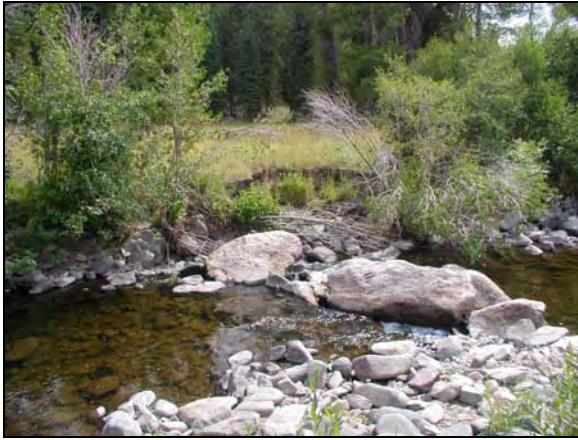
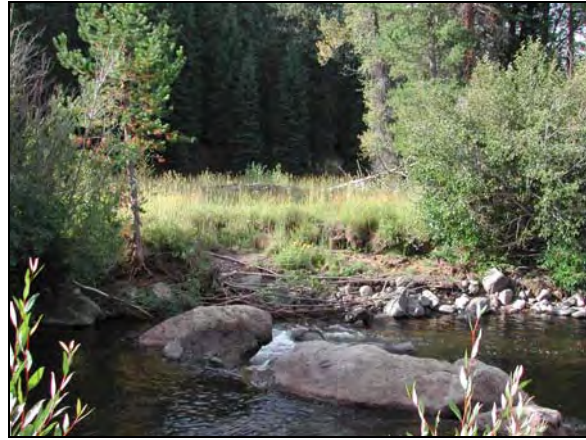
Near the upstream end of the project on the Middle Fork ($40^{\circ} 59.196' N, 107^{\circ} 2.094' W$), the boulders of a structure have shifted into a position that focuses flows on the left bank (Figures 33 through 36). Mass wasting during high flows in 2003 removed an 8-ft section of the willows from the bank. In 2005, the failure is still evident although new vegetation has established on the bank. Filling in this eroded section and emplacing additional boulders or other roughness elements along the bank would improve the stability of this location.

Figures 33-36: 2002, 2003, 2004, 2005 comparison of the 8-ft section where bank erosion removed willows (40° 59.196' N, 107° 2.094' W).

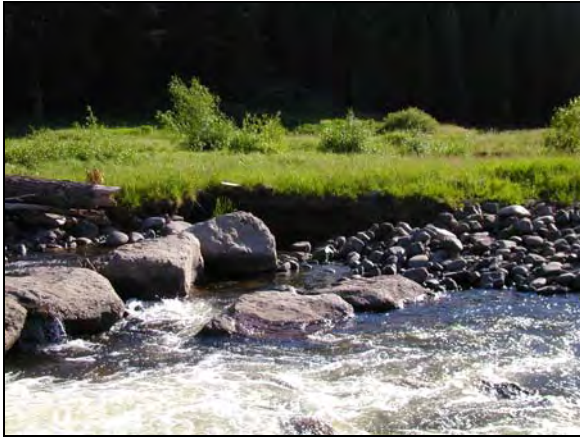
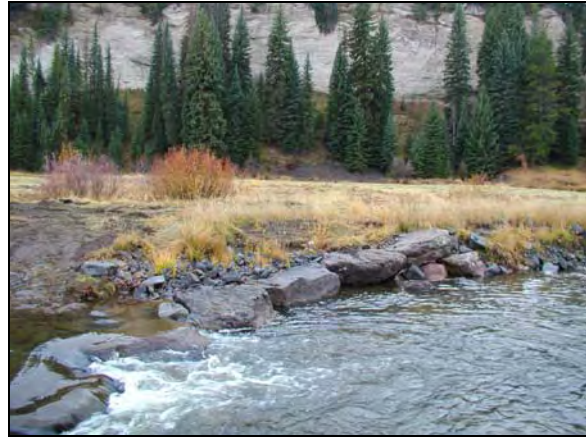
High flows in the spring of 2005 flanked the left side of the structure immediately upstream of the W-weir (Figure 37a). This structure was repaired by Wildland Hydrology in the fall of 2005 (Figure 37b).

Figures 37a-b: (a) Photograph taken on July 11, 2005, of flanking of the left side of the structure upstream of W-weir. (b) Photograph taken on October 20, 2005, of the same structure after repair.

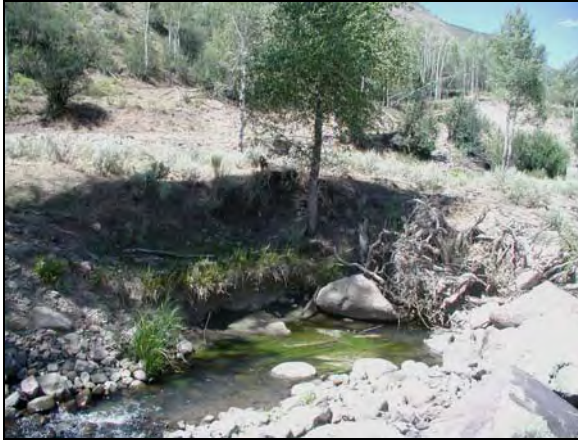
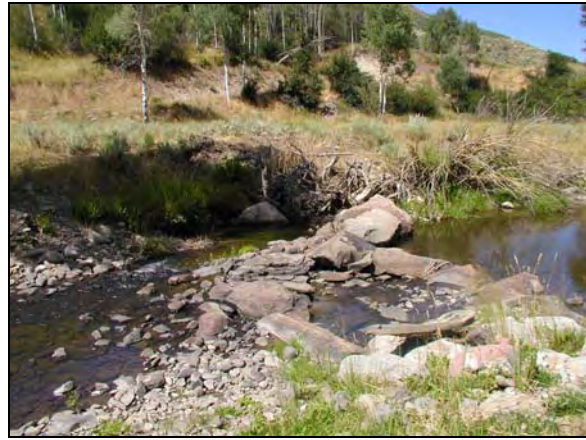
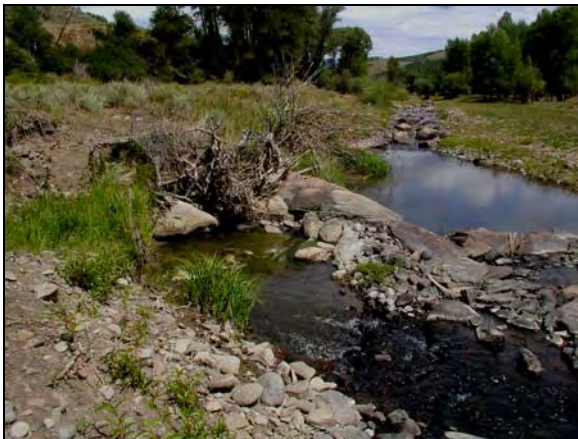
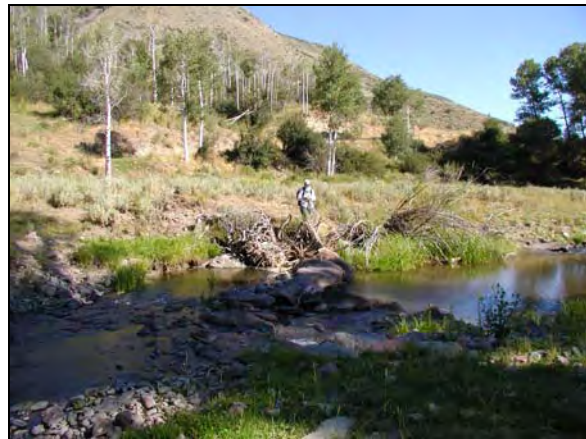
First, at a location identified in 2002 ($40^{\circ} 56.409' N$, $107^{\circ} 06.042' W$), high flows continue to erode the left side of a structure and have removed a small tree from the bank. This erosion is associated with eddying, resulting from flow under the structure at the bank toe. The site remains largely unchanged in 2005, with the exception of some new grasses on the left side of the structure in the failure.

Figures 38-41: Flow concentrated on the left bank took out small tree on the bank ($40^{\circ} 56.409' N, 107^{\circ} 06.042' W$). The site remains largely unchanged in 2005 (photograph taken on August 17, 2004).

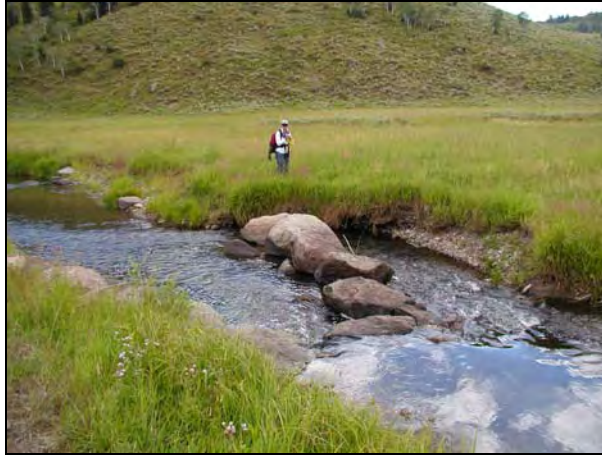
A few other locations along the South Fork exhibit similar erosion characteristics occurring where flow is concentrated on one side of a structure and is beginning to flank the structure. Figure 42 shows a location identified in 2005 where flow is flanking a structure on the right bank ($40^{\circ} 58.327' N, 107^{\circ} 03.151' W$).

Figure 42: Photograph taken on August 23, 2005, showing a South Fork structure flanked on the right bank ($40^{\circ} 58.327' N, 107^{\circ} 03.151' W$).

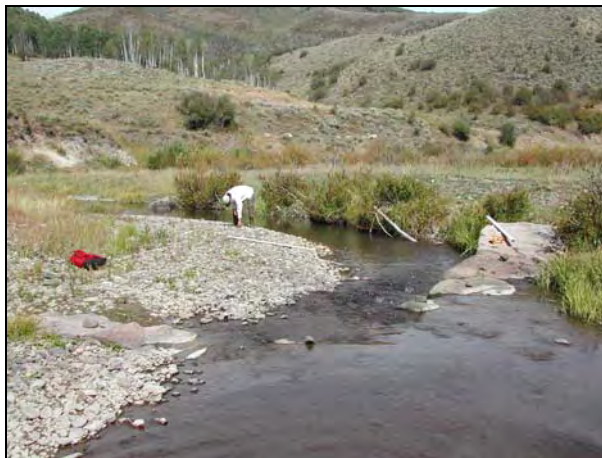
There are numerous locations along the South Fork where a point bar on the inside of a bend has migrated toward the channel centerline and resulted in filling of structures and thalweg shifts toward the outside of the bend (Figure 43). This results in greater shear stresses but has not resulted in substantial amounts of bank erosion due to vegetation established along the banks.

Figure 43: J-hook structure on the South Fork filling in by a point bar on the left bank opposite the tie-in ($40^{\circ} 57.203' N, 107^{\circ} 05.163' W$).
