MONITORING OF THE LITTLE SNAKE RIVER AND TRIBUTARIES

YEAR 5 - FINAL REPORT

December 2005

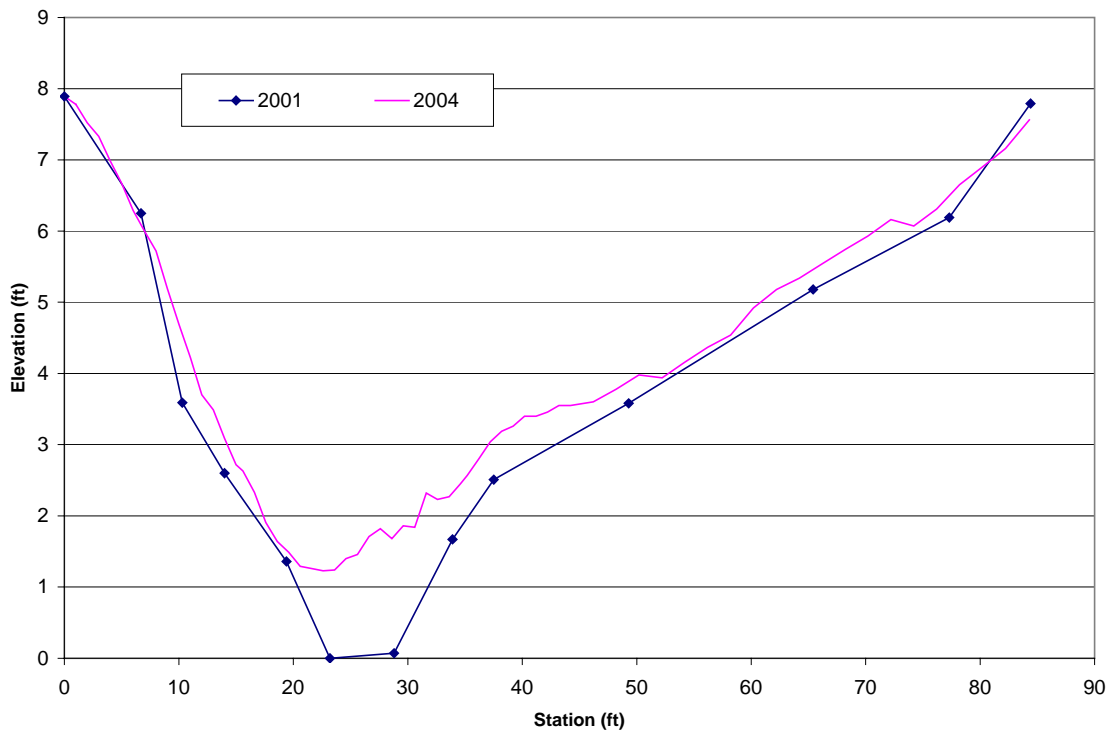
Detailed cross-section surveys were completed at twenty-five locations in the summers of 2001 and 2004 to assess changes in channel morphology and stability. All survey measurements of channel cross sections were recorded at a vertical resolution of 0.01 ft. The horizontal resolution of the 2004 cross sections was increased relative to the 2001 cross sections. Comparisons of thalweg elevations from each year reveal a general trend of aggradation at the cross sections, as shown by the representative cross section presented in Figure 6. The average amount of aggradation among all cross sections is 0.66 ft, with a standard deviation of 0.65 ft.

Figure 6: A representative cross section comparison between 2001 and 2004 surveys indicating aggradation at SF XS6A.

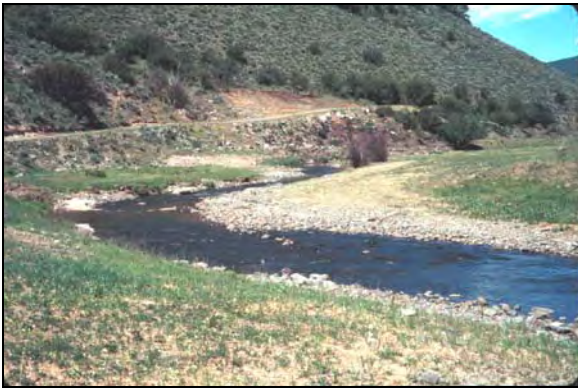
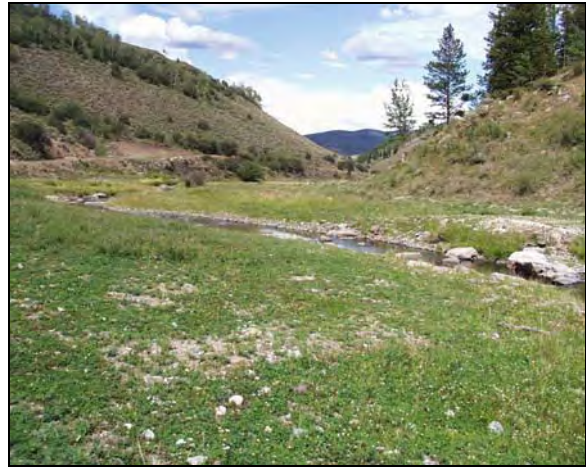
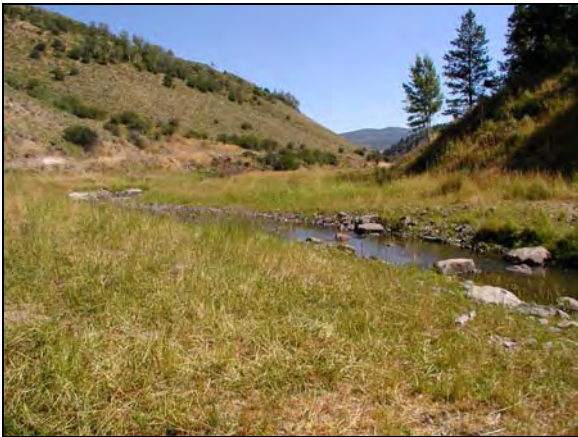
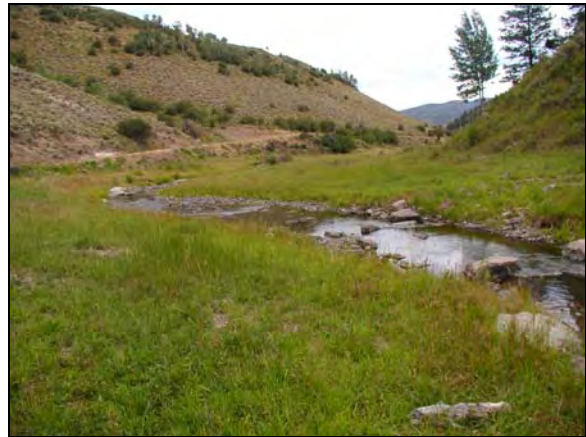
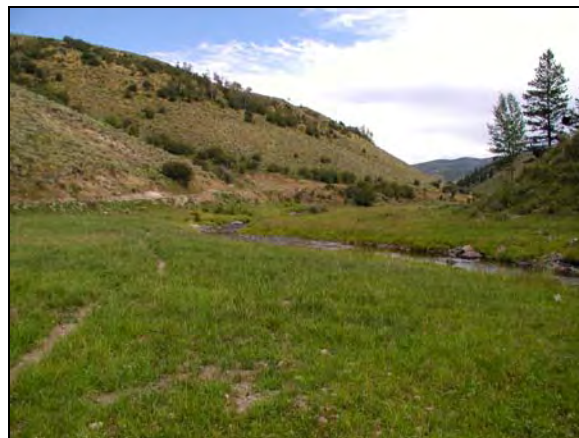
Photo points located throughout the project provide a means to observe changes in vegetation over time. Figures 7 through 11 depict a representative progression of vegetation colonization along a cobble bar of the South Fork of the Little Snake, while Figures 12 through 16 depict a similar representative progression along the Main Stem. Although this vegetation establishment is encouraging, it is not limited to reaches within the project. At an additional photo point located downstream of the end of the project, similar colonization is occurring (see Figures 17 through 21). This could be related to upstream restoration activities, or could be an indicator that vegetative changes are partially due to climatic factors. Vegetation colonization in lower levels of the channel may reflect successive low-flow years during the drought cycle. Vegetation has thrived throughout the restoration project since construction, despite drought conditions. Much of this improvement is attributable to improved grazing practices and enhanced hydrologic connectivity of the riparian corridor resulting from the restoration project.

Figures 7-11: Sequence of vegetation establishment along the South Fork (photo-point SFPP18, looking downstream).

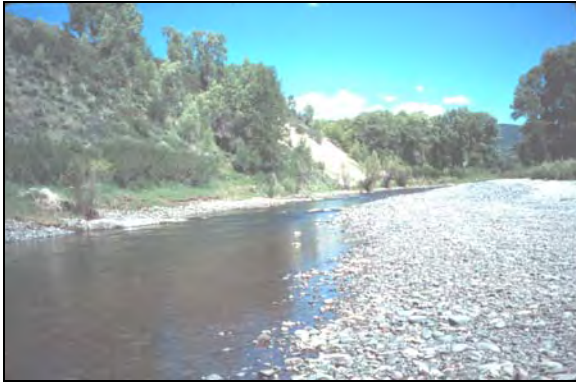
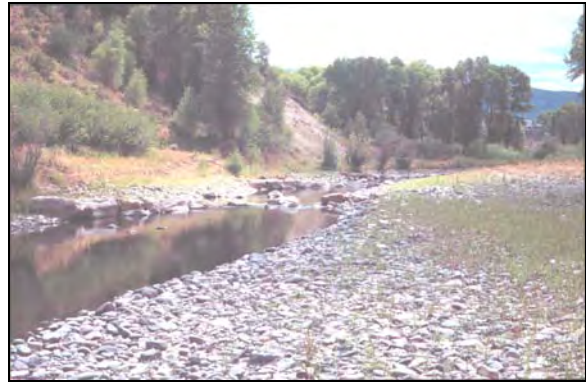
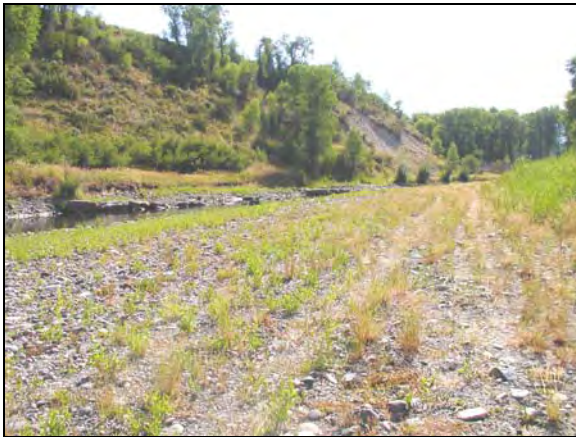
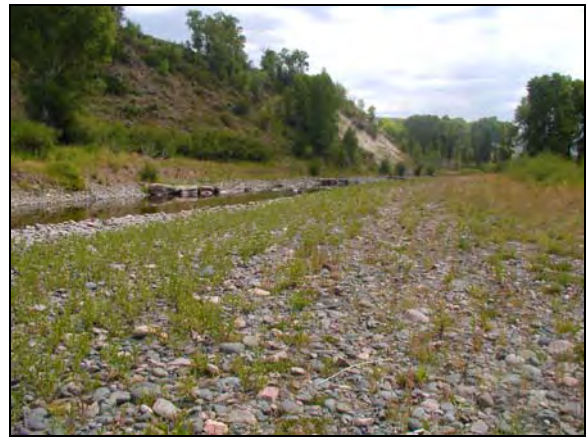
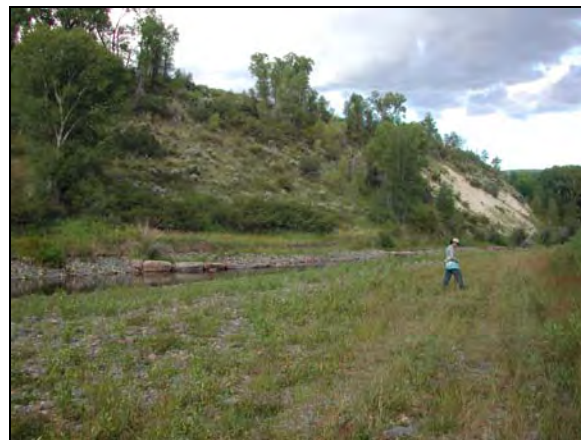
Figures 12-16: Sequence of vegetation establishment along the Main Stem (photo-point MSPP4, looking upstream).

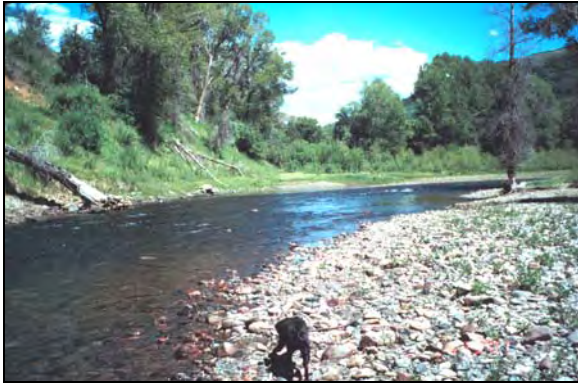
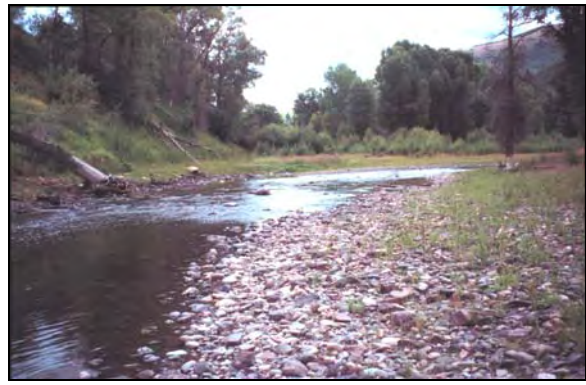
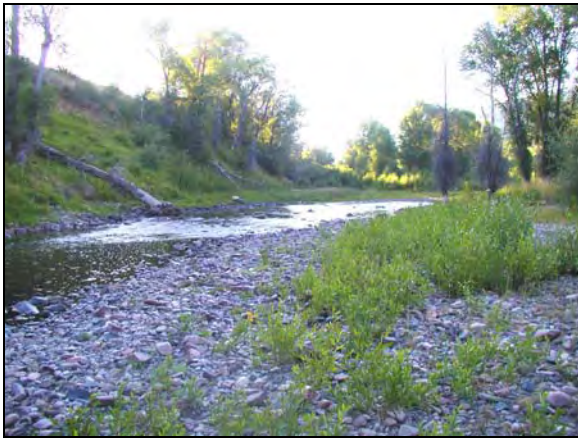
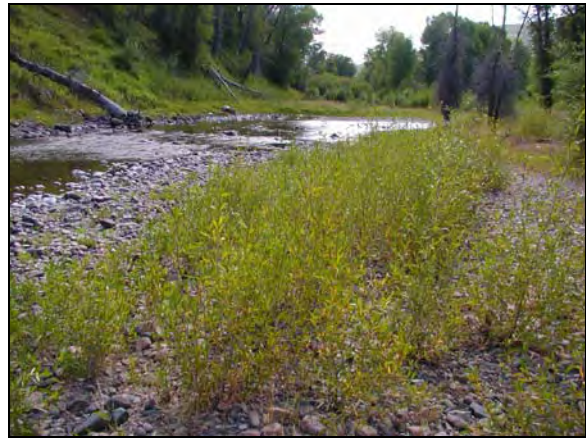
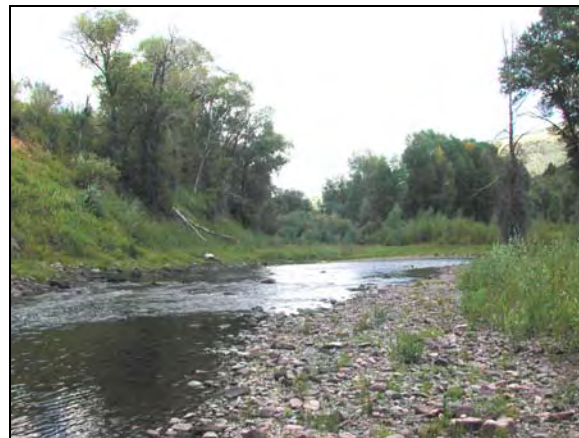
Figures 17-21: Sequence of vegetation establishment along the Main Stem, downstream of the project boundary (photo-point MSPP10, looking upstream).

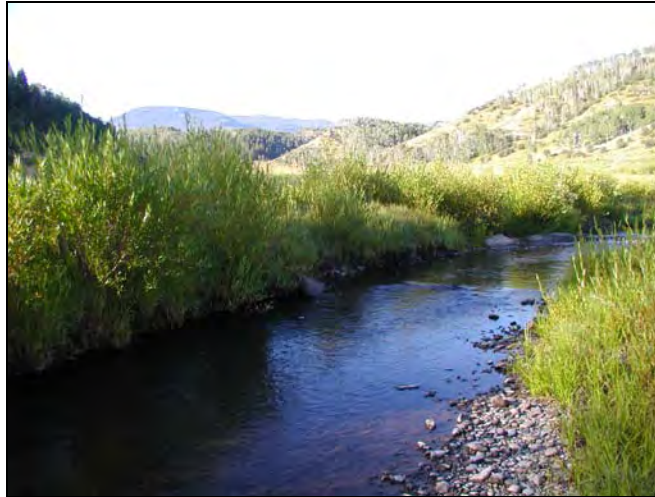
Riparian vegetation was denser in 2005 than in previous years, especially along the lower South Fork, with the high flows and wet early summer. Figure 22 shows one representative location on the lower South Fork in the pasture immediately upstream of the South Fork Bridge flow-meter site.

Figure 22: Representative riparian vegetation along the lower South Fork. Note the shading provided to the bend pool by willow establishment.

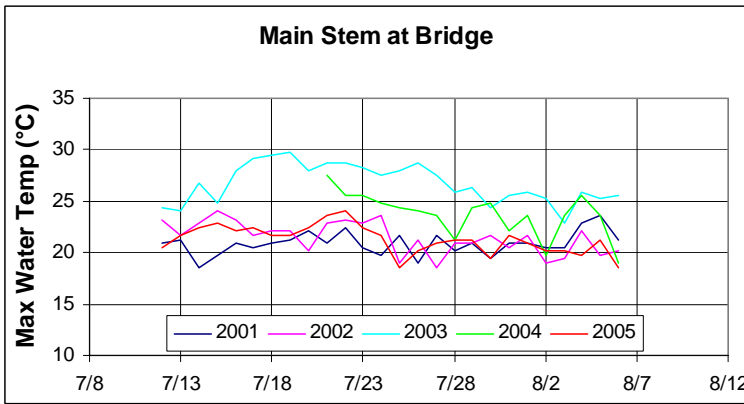
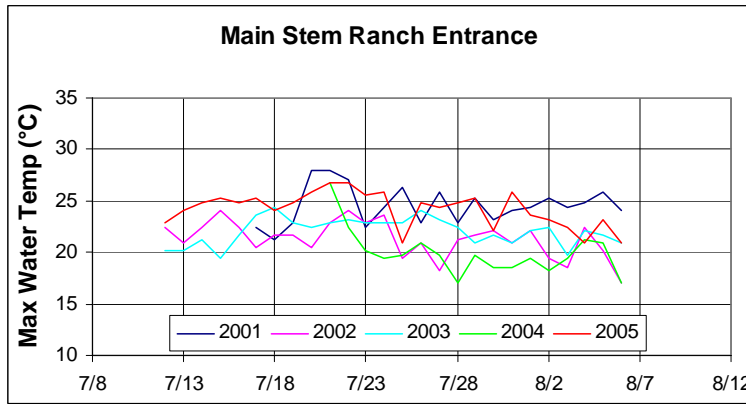
Figures 58-59: Comparison of 2001 through 2005 maximum water temperatures along the Main Stem.
