# GEOMORPHIC, HYDROLOGIC AND ECOLOGICAL EFFECTS OF THE BEAR CREEK MEADOW RESTORATION PROJECT: A LAYMAN'S REVIEW

PREPARED BY:  
CHRISTOPHER T. HAMMERSMARK  
&  
JEFFREY F. MOUNT

NOVEMBER 15, 2005

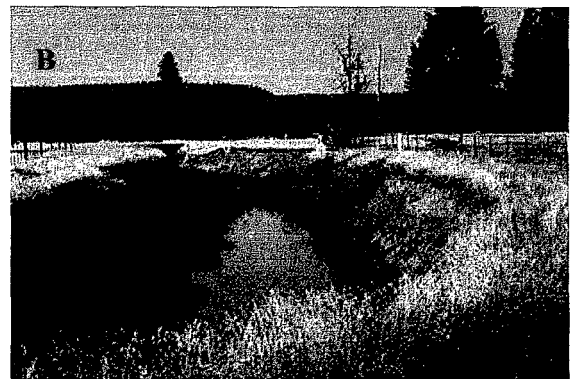
**Figure 2** – **A)** Tall, near vertical unvegetated banks of the pre-restored Bear Creek channel. **B)** Prior to restoration, Bear Creek was best described as a gully (Photos: Rick Poore).

As the stream channel incised and lowered the ground water table, the stream banks progressively grew very tall and steep, and unable to support much vegetation which lead to increased instability of the stream banks (Figure 2). This instability initiated a cycle of lateral erosion of the banks, widening the channel. This lateral channel enlargement confined more water within the channel and contributed even more sediment to the Fall River. Bear Creek's once numerous shallow, vegetated, and meandering channels had degraded into what are best described as two unstable, erosive gullies (Figure 2).

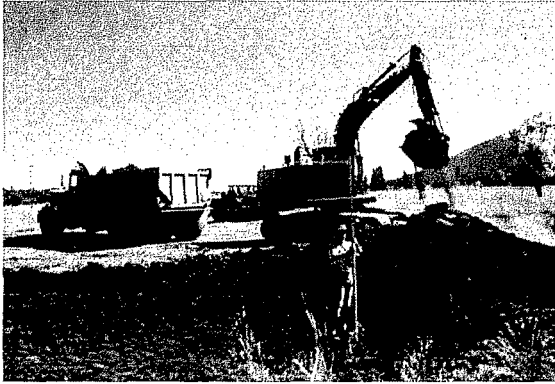
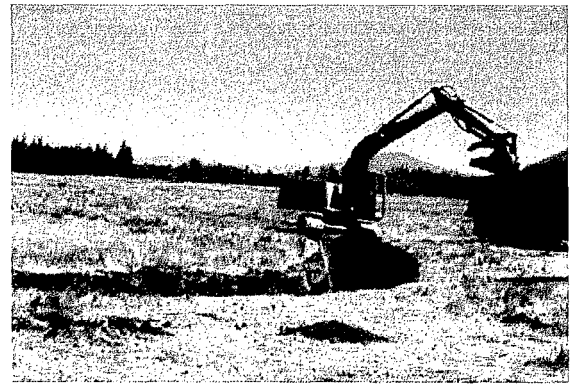
**Figure 3** – Sculpting the restored channel in the summer of 1999 (Photos: Rick Poore).

derived from nearby floodplain deposits, creating several large ponds within the meadow. The restored channel was constructed using remnant channel reaches where available and practical, and the remaining reaches were sculpted with heavy machinery in the size and shape of the historic meadow channels (Figure 3). Based upon the recommendation of the expert panel, gravels were added to the restored channel to enhance fish spawning habitat and to reduce bed erosion. Upon the completion of the project, 2.2 miles of restored stream, and 42 acres of new ponds, almost ten percent of the meadow area, existed in the Bear Creek Meadow (Figure 4). These ponds consisted of two types: large ponds created by the need for fill material, and smaller linear ponds, which are remnants of the old gullies.

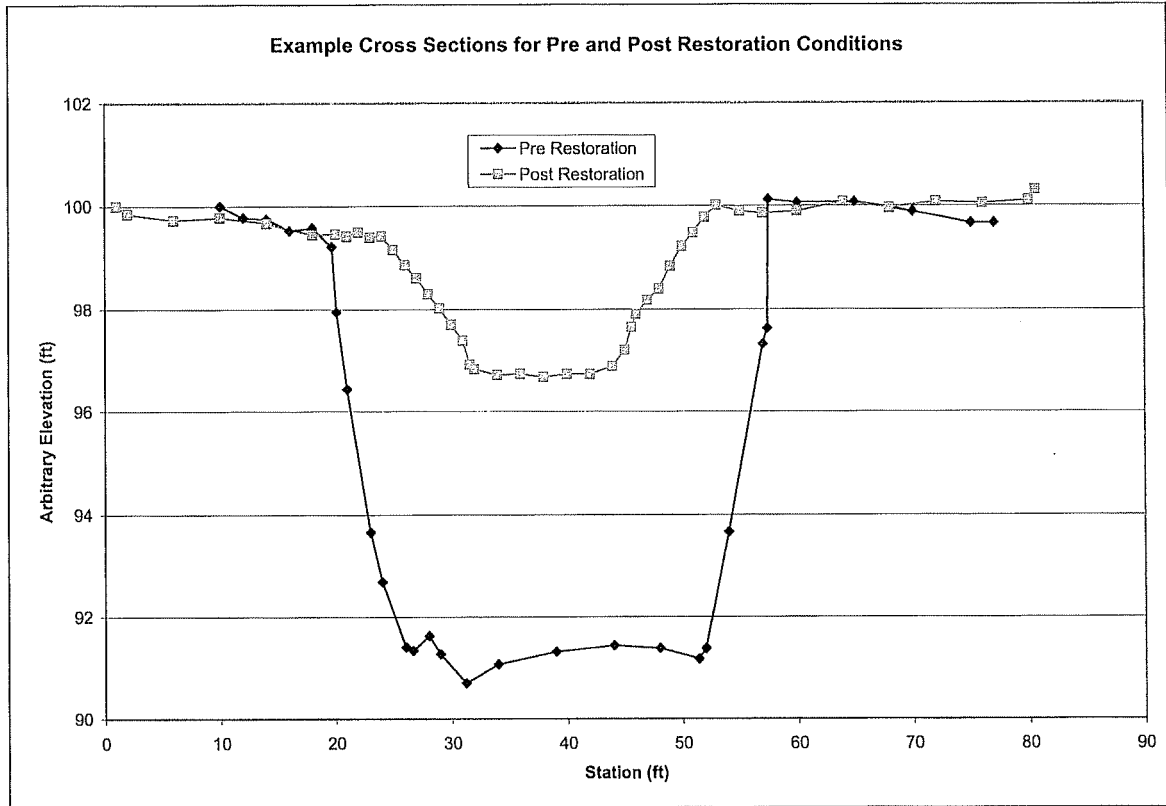
**Figure 5** – Representative cross sections of Bear Creek in the pre restoration (blue with diamonds) and post restoration (red with squares) project conditions. Notice how much larger (deeper and wider) the pre restoration channel is when compared to the restored channel.

The plugging of the old, over-sized channel and creation of the new, small main channel for Bear Creek re-established the geomorphic processes typical of a meadow. Based on annual surveys of more than 20 channel cross sections (Figure 5), the sinuous, shallow channel has remained relatively stable in the period since completion of the restoration project. Rapid channel adjustments involving incision or significant lateral migration have not been widespread although minor redistribution of sediment has been observed. The causes of this sediment redistribution are under investigation by UC Davis and Streamwise, Inc., but appear to involve local excessive slope or flow confinement. The few instabilities have been addressed by Streamwise, Inc. through a variety of bank stabilization techniques.

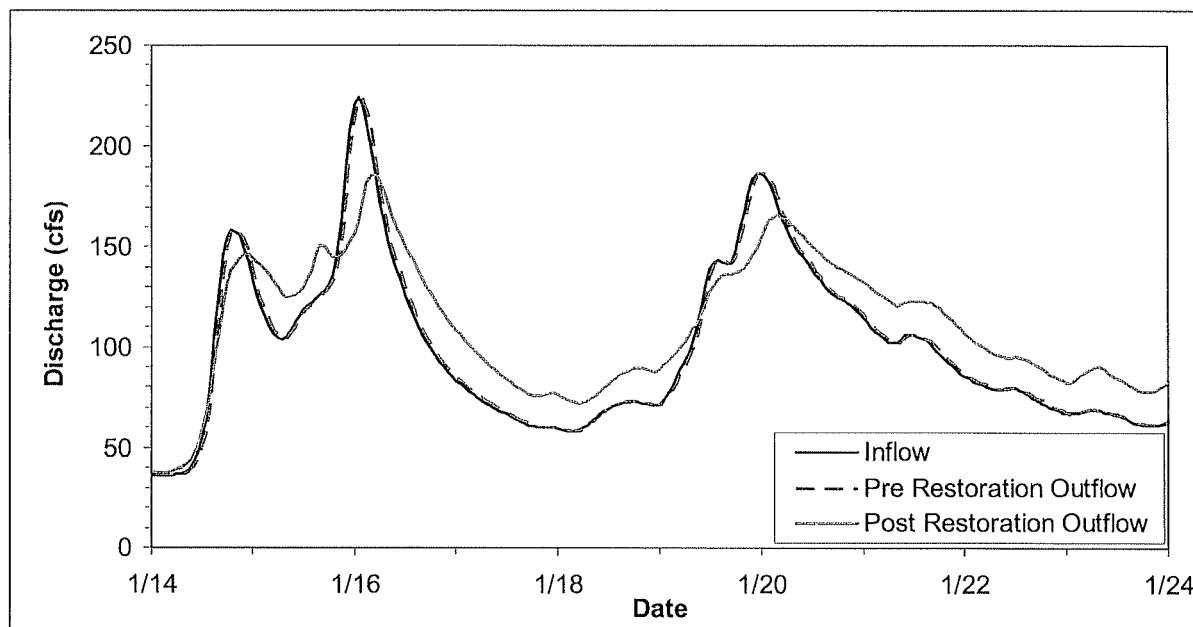
**Figure 7** – Preliminary hydraulic modeling results reveal the effect of the channel restoration on the movement of several flood pulses through the meadow. In the pre-project incised condition (green dashed line) each flood pulse travels through the meadow relatively unchanged. In this case the meadow outflow (green dashed line) is very similar to the meadow inflow (blue solid line). Due to a lack of floodplain connectivity in the incised condition, flood peaks maintain their magnitude and travel through the meadow rather quickly. In the post-project, restored condition, significant attenuation and peak reduction are observed in the meadow outflow (red solid line). As water leaves the main channel and inundates the floodplain, it is slowed and temporarily stored. While some of this water flows back to the channel downstream after flowing across the floodplain, some of the water infiltrates into the meadow surface and recharges the shallow water table.

As floodplain inundation occurs, floodwaters are slowed and temporarily stored on the meadow surface before either flowing back into the channel at a downstream location, or infiltrating into the meadow, recharging the ground water table (Figure 6). One effect of this restored connection between the channel and the floodplain has been that downstream flood peaks, or the elevation of floods, have been significantly reduced. In addition, due to temporary storage of floodwaters on the floodplain, the length of time that it takes for a flood pulse to move through the meadow increased substantially, enhancing the amount of recharge to shallow ground water. Therefore, while softening the impact of floods, the restored channel-floodplain connection has also greatly enhanced ground water conditions. Quantifying the magnitude of these changes is the subject on going research by UC Davis researchers; however some preliminary results illuminate some anticipated trends (Figure 7).

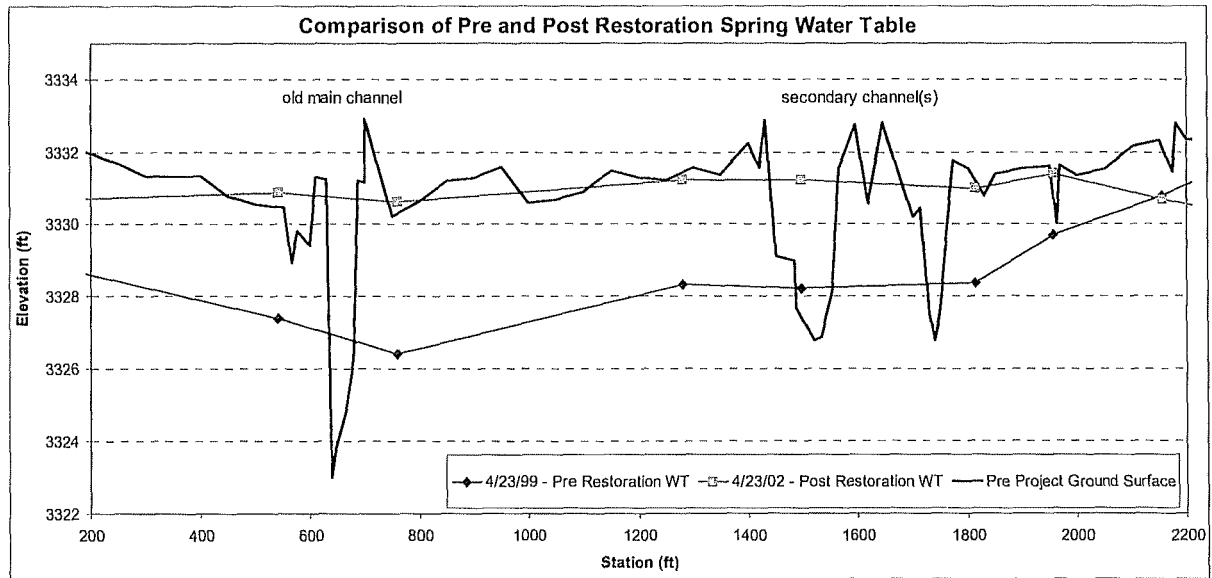
**Figure 8** – Comparison of pre- (blue line) and post-restoration (red line) water table elevations in late April for ground water transect B. Transect B traverses the valley roughly half way down the meadow. The pre-restoration ground surface is provided to show the locations of old main channel and secondary channels, in addition to allowing the comparison of the restoration's influence on the depth to the water table. Note that the pre-restoration water table slopes toward the old main channel, as it acted as a drain for the meadow's ground water.

In the pre-project state, the deeply incised gully intercepted the ground water table and effectively drained it (Figure 8). The ground water surface sloped toward the gully and, during low flow conditions; ground water would discharge into the gully and be carried into the Fall River. Plugging the gully with soil eliminated this ground water drain, allowing the ground water table throughout the meadow to recover. This coupled with the frequent flooding of the floodplain and recharge of the meadow aquifer through the relatively shallow restored channel has restored ground water throughout the meadow to conditions that are roughly similar to those prior to channelization. Preliminary calculations indicate that currently during the spring, the meadow stores 195 acre-feet of water more than it did during pre-project conditions (an acre-foot is 325,851 gallons of water, roughly equivalent to the water necessary for a single household for one year).
